**Geotechnical Investigation
New Storage Tanks
9 Egret Street, Kooragang Island**

Project 81320
9 July 2013
SAM:kd
P:\81320\Docs\81320.doc

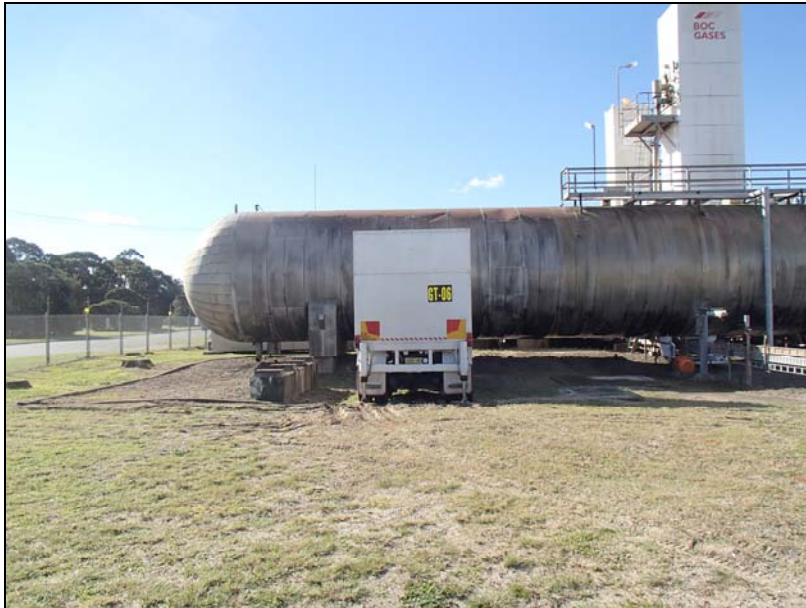
Figure 1: View of site at CPT 302

The ground surface of the site is near level (RL 3.6 AHD to 4.3 AHD) and comprises mainly grass covered sand and concrete pavements.

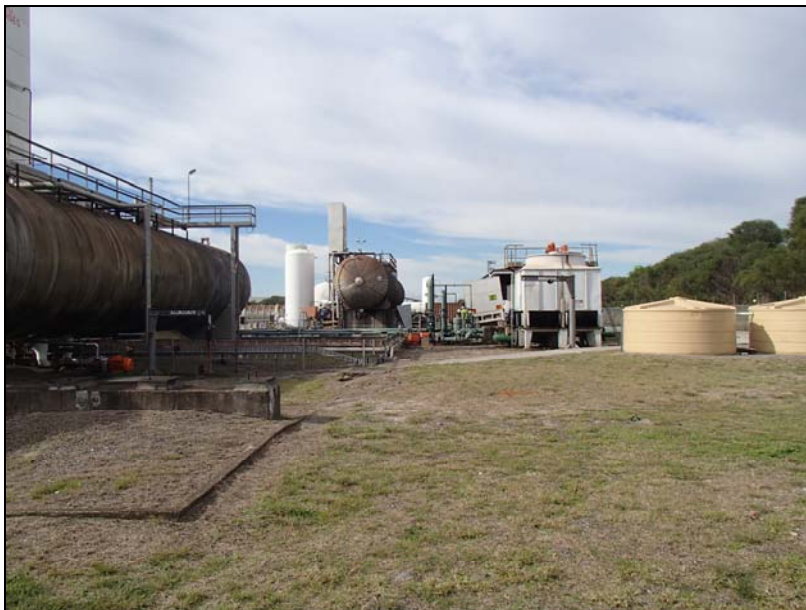
Figure 2: View looking east from CPT 302 to CPT 301
