BOC Kooragang DA 8354 Response to Request for Response to Submissions June 2017

BOC Limited Kooragang Island

22 June 2017

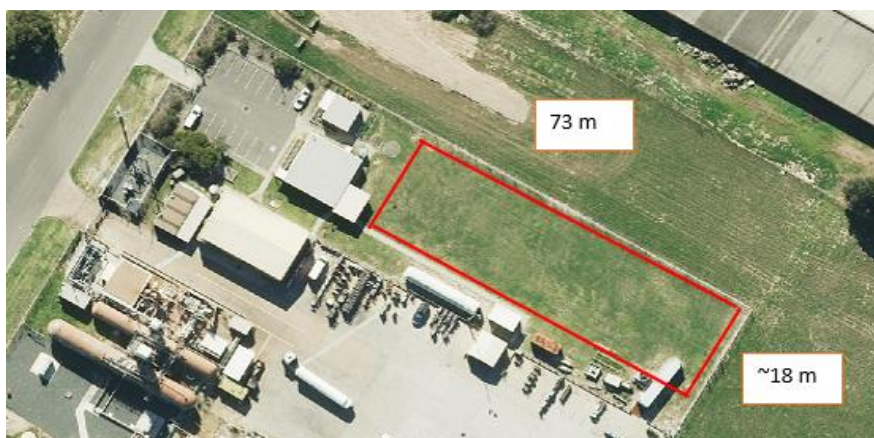
Figure 4-1: Original proposed irrigation area Figure 7-1 from SEE

The original Figure 7-1 is reproduced in Figure 4-1 which was calculated at 1,314 m².

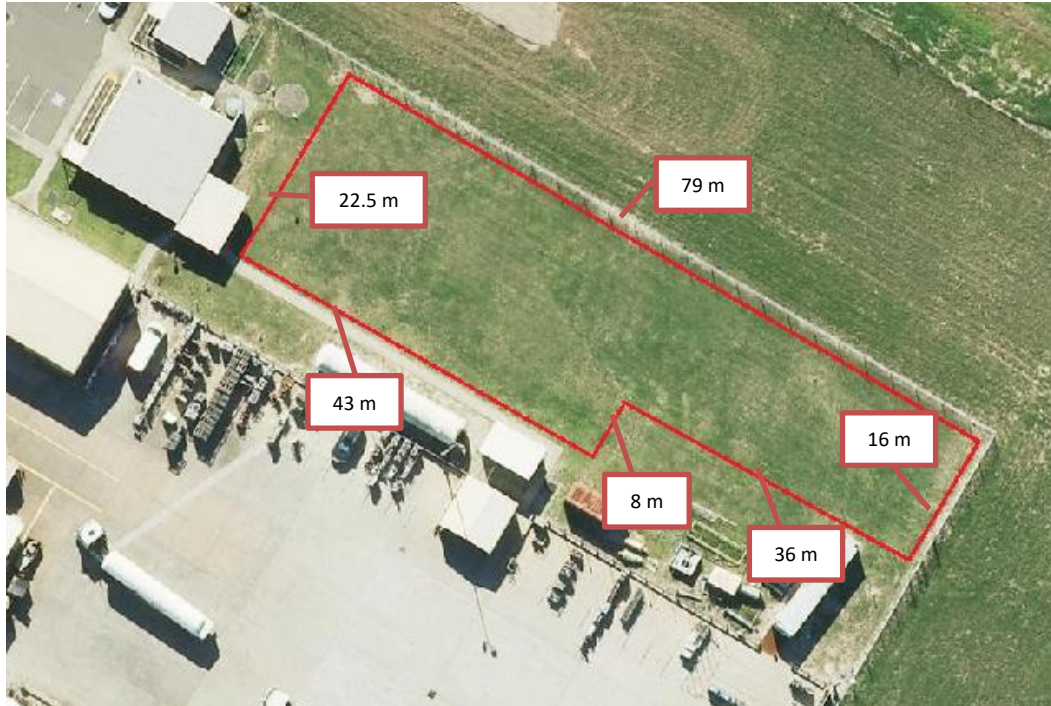
**Figure 4-2: Reviewed proposed irrigation area**

Figure 4-2 shows the reviewed proposed irrigation area. The area has been measured and confirmed by site management and includes only grassed areas. The total revised area is 1,544 m² (0.15 hectare).

The calculated area is slightly larger than the originally calculated area of 0.13 ha. The water balance, nitrogen and phosphorus balance calculations have therefore been repeated in this document.

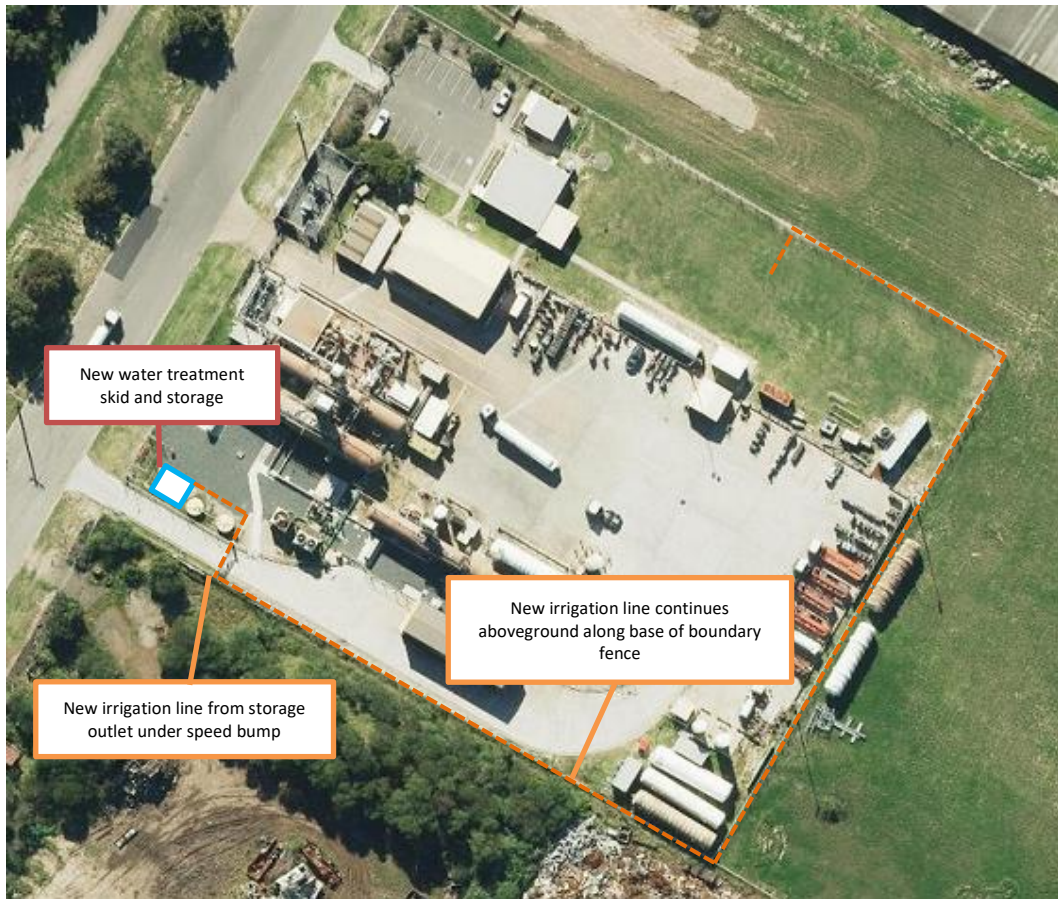
Figure 4-3: Proposed revised irrigation pipework system diagram

In the time between the submission of the DA BOC Kooragang has revised the original pipework which is also presented in Appendix C, and below in Figure 4-3.

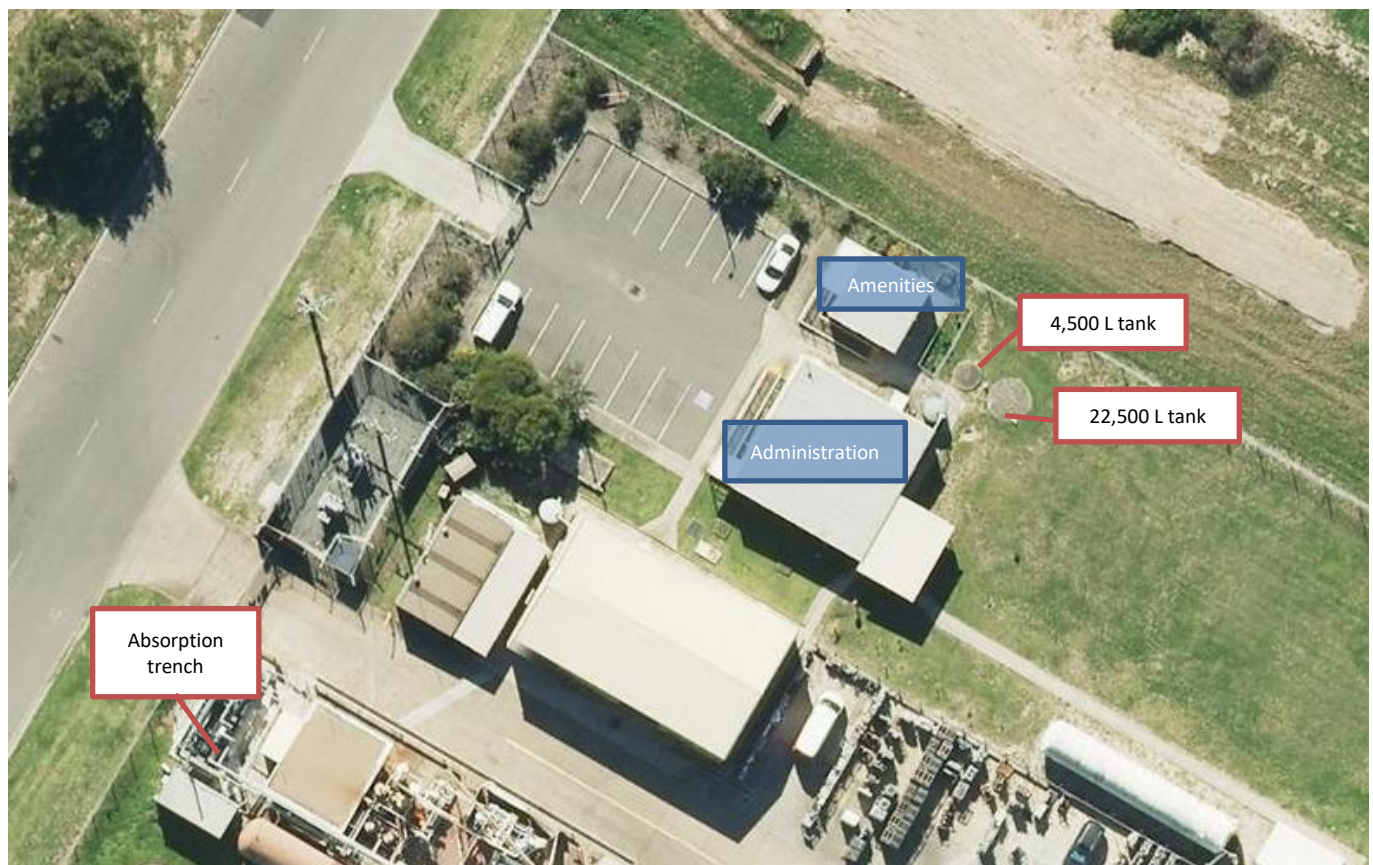
Figure 5-1: Septic system and absorption trench locations

BOC Koorangang operates a septic system with a pump-out performed for disposal. The system's location is shown in Figure 5-1.

The system is located outside an amenity block and receives wastewater from the following sources:
